NW-1, 29 OCT 2026 to 26 NOV 2026

SEATTLE-TACOMA INTL AIRPORT

ALERT NOTICE

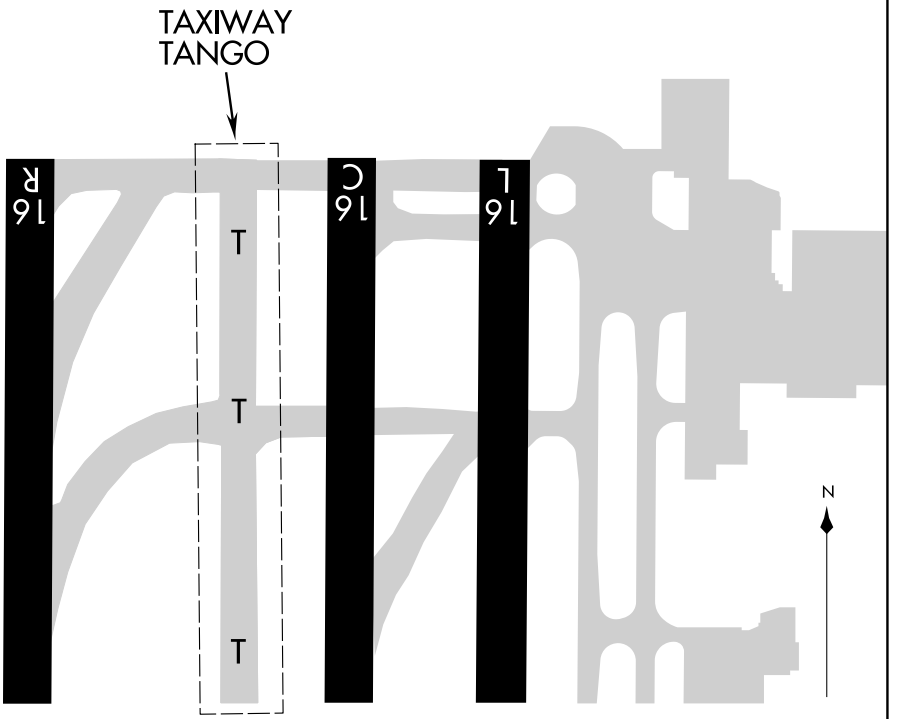
When transitioning from an instrument procedure to a visual approach to Runway 16C, verify that you are aligned for the intended landing Runway, not Taxiway Tango. Taxiway Tango is west and parallel to Runway 16C.

Taxiway Tango has been mistaken for Runway 16C from the air during certain visibility conditions, i.e., wet runway, low sun angle reflections. Aircrews are advised to be aware of the proximity of the taxiway to Runway 16C and its runway-like appearance while on approach.

Aircrews should use visual cues, e.g., approach lighting systems, REILs, when available, to confirm alignment with Runway 16C not Taxiway Tango. Additionally, it is recommended to track the localizer until the runway environment is visually verified.
