Flight Procedure Tracking Form		Action: AMENDMENT	Task Type: IAP	Date Open: 08/09/2018	Task #: 2018080934600001003	Request #: 20180809346000
Procedure: LOC RWY 23 AMDT 7J			Airport ID: KMWO	Airport: MIDDLETOWN REGIONAL/HOOK FIELD		Reimbursable #: NO
City: MIDDLETOWN	ST: OH	GPS #:	Estimated Chart Date: 06/20/2019		FICO #:	
Fac ID: MWO		Fac. Type: LOC			Specialist: LEO PALMER	
Procedure Review						
	Rec'd	Rel'd	Full Name	Comments		
Lead:	11/15/2018

LOC RWY 23

MIDDLETOWN RGNL/HOOK FIELD (MWO)

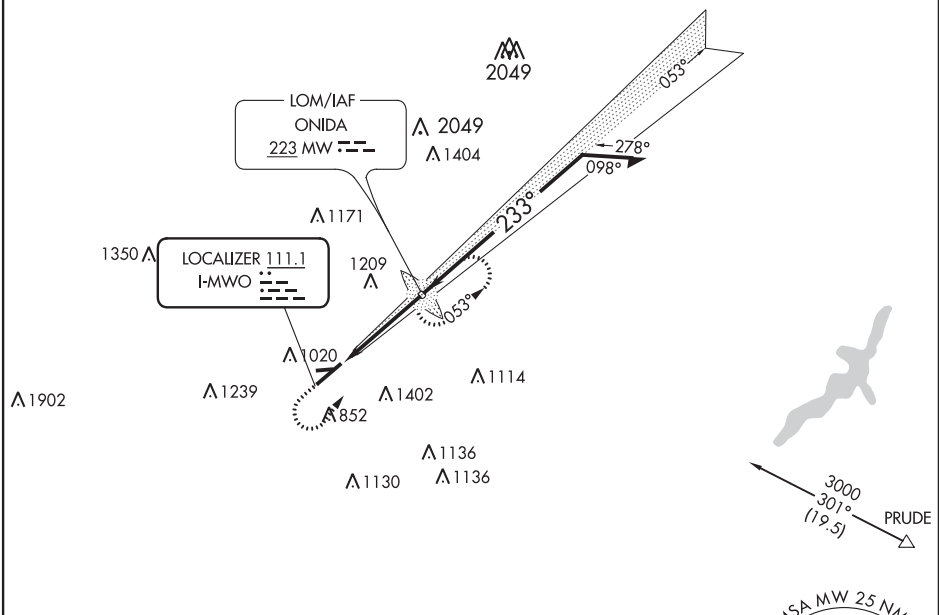
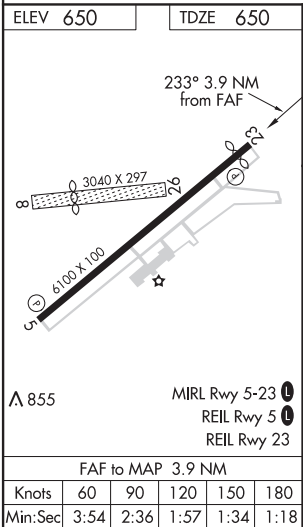
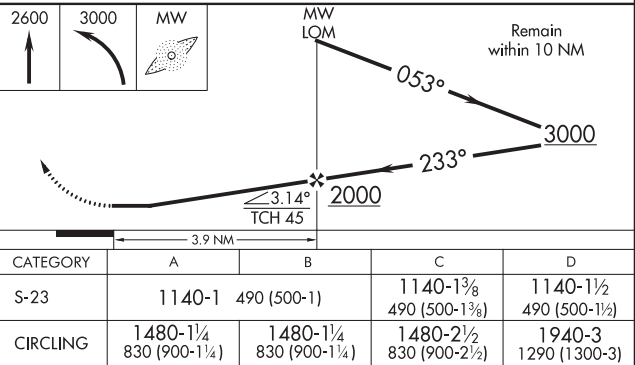
LOC RWY 23

LOC I-MWO	APP CRS	Rwy Idg	5801
111.1	233°	TDZE	650
		Apt Elev	650

MISSED APPROACH: Climb to 2600 then climbing left turn to 3000 direct MW LOM and hold.
